Nokero SunRay Pro Power Panel Capacitor Replacement

The P102 model comes equipped with a 100 microfarad capacitor. If your panel is not able to transfer a charge to your device, you may need to replace the capacitor.

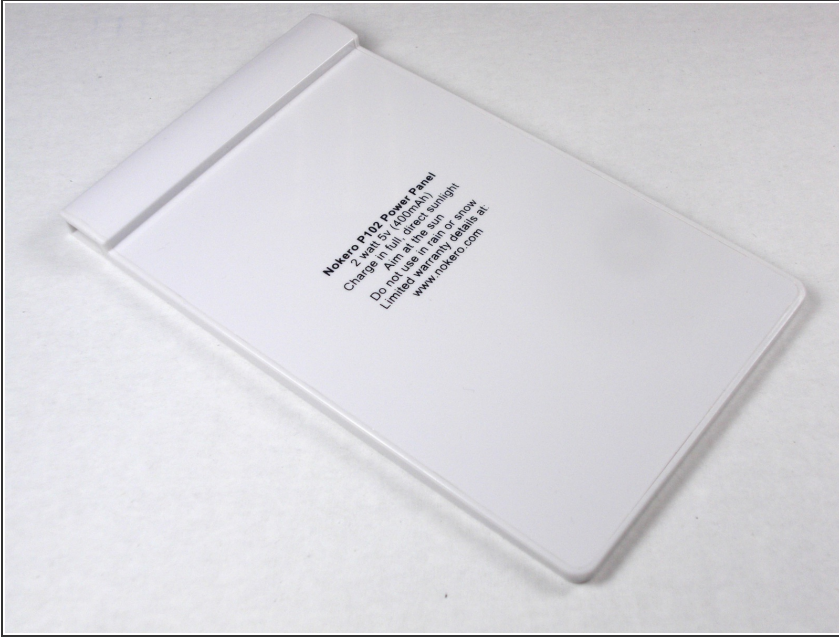
Step 1 — Front and Back Case

- Turn over the device so that the back of the device is facing up.

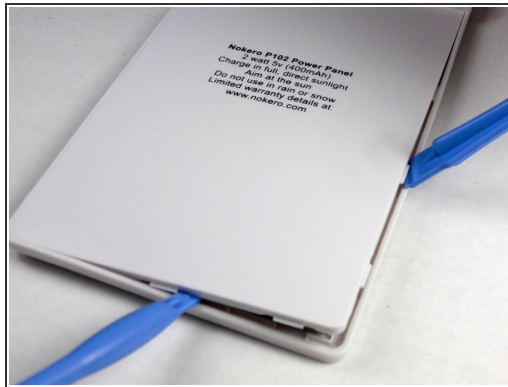
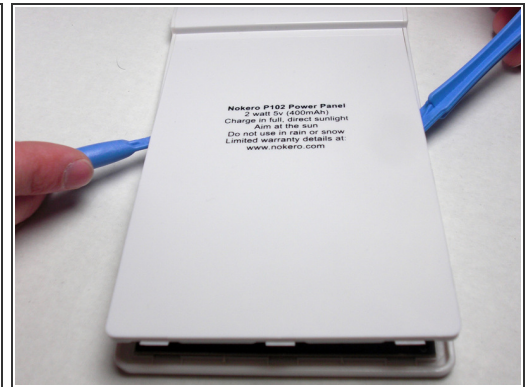
Step 2

- Insert the first plastic opening tool along the side to pry open the case.
- ⓘ Sliding the plastic opening tool, while inserted, along the seam may help the removal process.
- Use a second plastic opening tool to help separate the remaining seams.

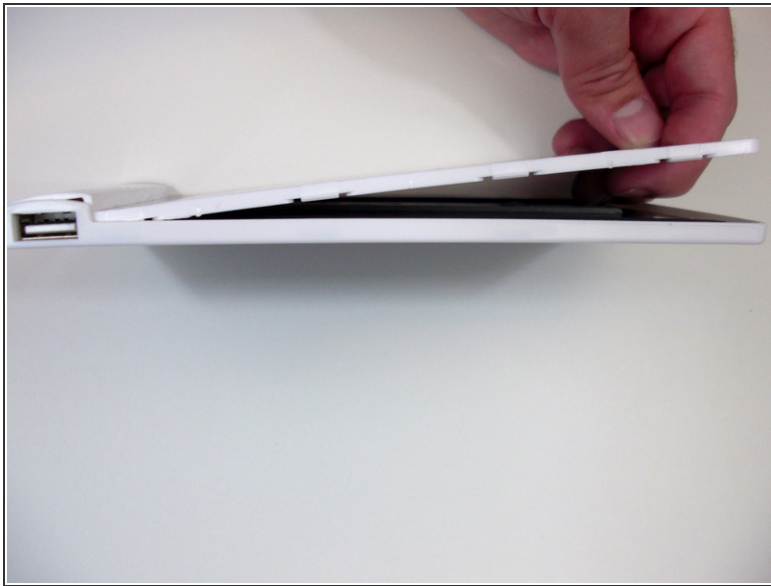
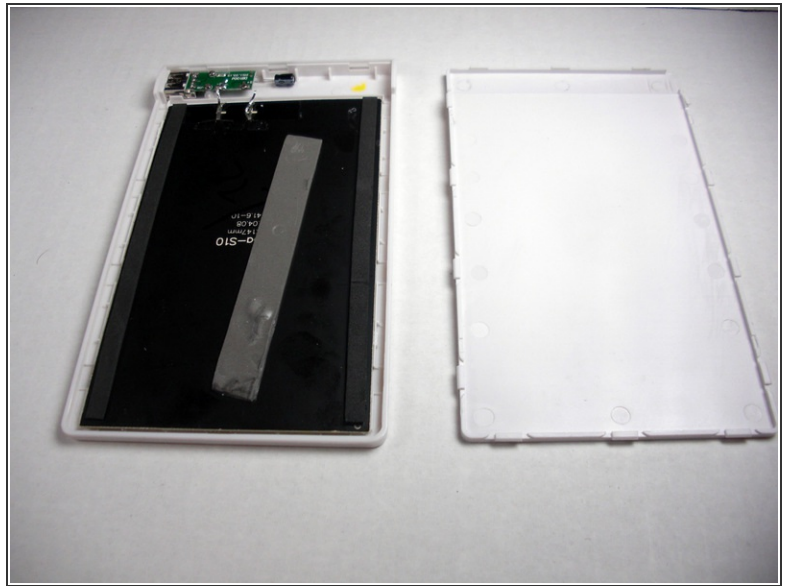
Step 3

- i** There is a long strip of double sided adhesive foam tape that prevents the back case from easily being removed.
- Pull the back case off by applying steady pressure to remove it from the adhesive foam tape.
